DEPARTMENT OF TRANSPORTATION

Quality Assurance and Source Inspection

Contract #: 04-0120F4Cty: SF/ALA Rte: 80 PM: 13.2/13.9File #: 69.28**WELDING INSPECTION REPORT****Resident Engineer:**Siegenthaler, Peter**Address:** 333 Burma Road**City:** Oakland, CA 94607**Report No:** WIR-023830**Date Inspected:** 18-Apr-2011**Project Name:** SAS Superstructure**OSM Arrival Time:** 700**Prime Contractor:** American Bridge/Fluor Enterprises, a JV**OSM Departure Time:** 1900**Contractor:** Zhenhua Port Machinery Company, Ltd (ZPMC), Changxing Island **Location:** Shanghai, China**CWI Name:** Xu Le Feng**CWI Present:** Yes No**Inspected CWI report:** Yes No N/A**Rod Oven in Use:** Yes No N/A**Electrode to specification:** Yes No N/A**Weld Procedures Followed:** Yes No N/A**Qualified Welders:** Yes No N/A**Verified Joint Fit-up:** Yes No N/A**Approved Drawings:** Yes No N/A**Approved WPS:** Yes No N/A**Delayed / Cancelled:** Yes No N/A**Bridge No:** 34-0006**Component:** OBG & TOWER Components**Summary of Items Observed:**

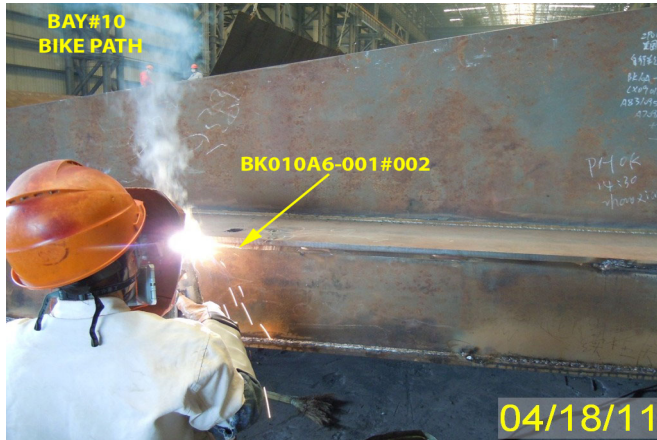
Weld joint #002 located on Bike path BK010A6-001. Welder is identified as 053829. ZPMC Quality Control (QC) Inspector is identified as Li Jun. The welding variables recorded by QC appeared to comply with the WPS-B-T-2312-Tc-P4. (See attached photo)
